## SEISMIC EVALUATION REPORT

### Charleston Fire District

#### Seismic Assessment for Fire Station 1

January 23, 2026  
22045.00

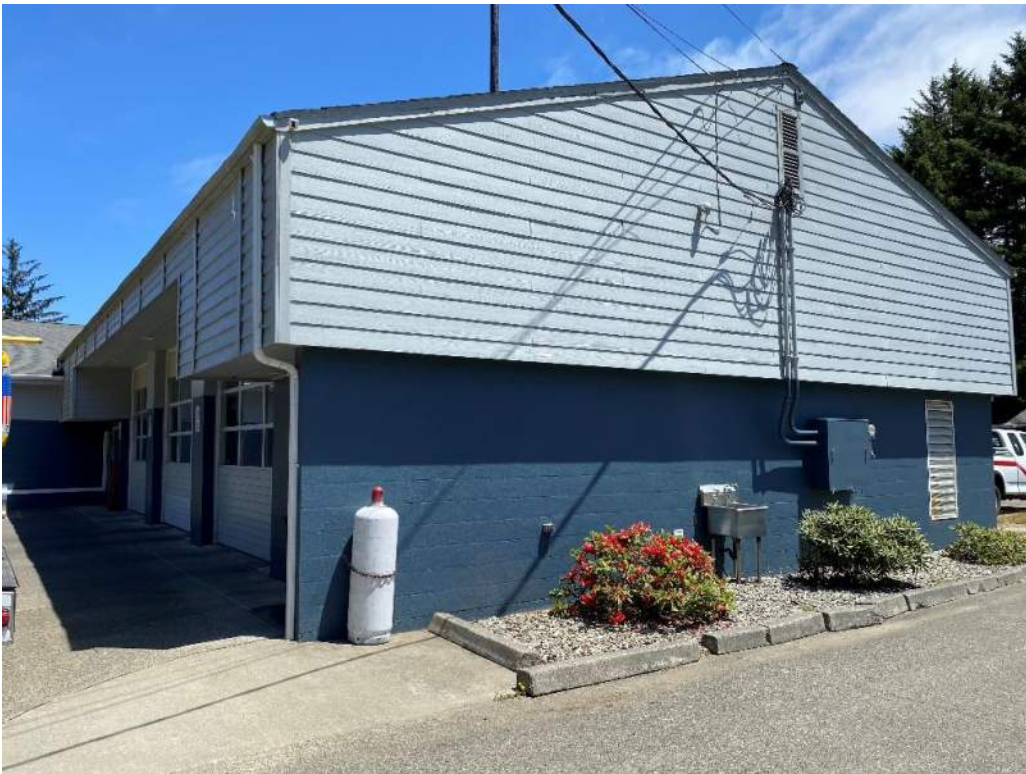
**Image 4: South Elevation with URM Walls Below Wood Bearing Walls**

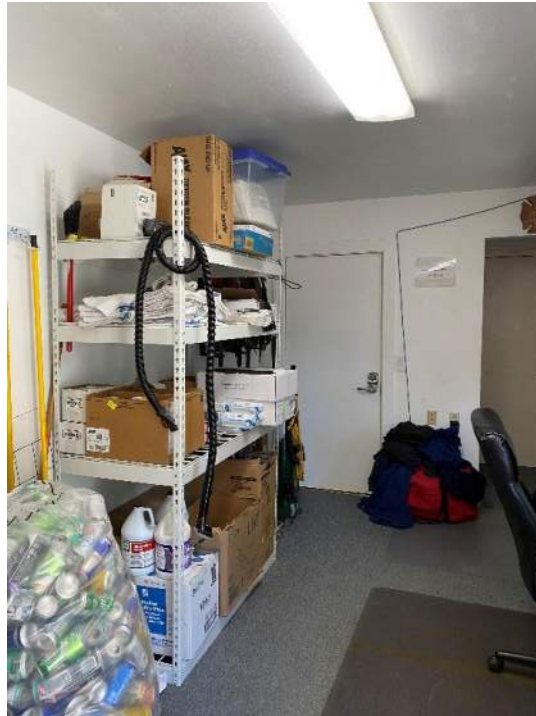
**Image 7: Unbraced Shelving**

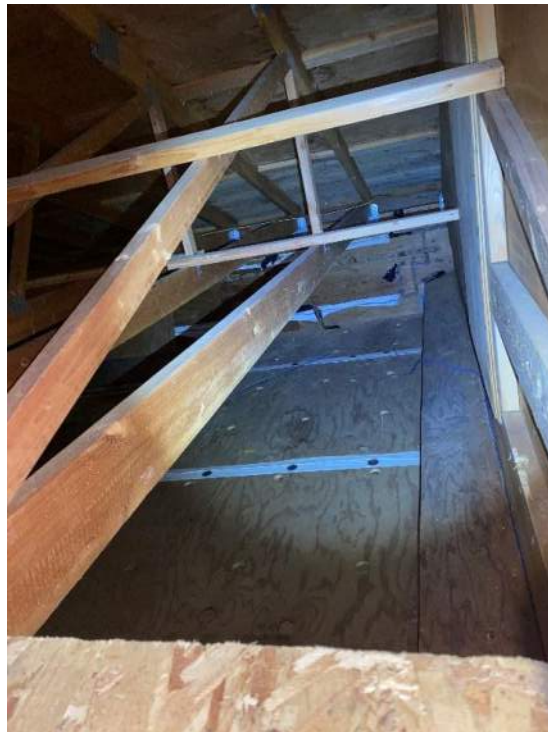
**Image 8: Roof Truss Overbuild Framing**

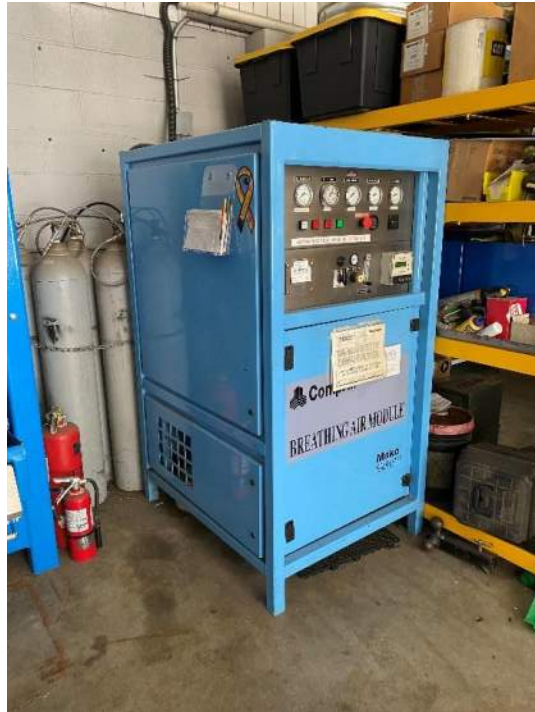
**Image 9: Unanchored Equipment**

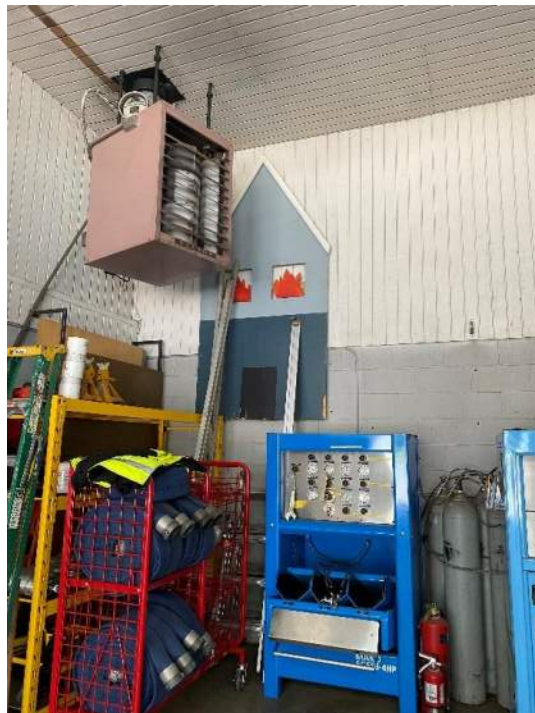
| <b>TABLE 3 – STRUCTURAL</b><br><b>Deficiencies &amp; Strengthening Measures</b><br>Immediate Occupancy Performance Level | | | |
|---|---|---|---|
| <b>S2</b> | Vertical Irregularities | Vertical elements in the seismic-force-resisting system are not all continuous to the foundation. | Brace "hinge point" with HSS strongbacks from foundation to roof. |

**Image 10: Unbraced Suspended Equipment & URM Wall Below Wood Stud Wall "Hinge" Point**

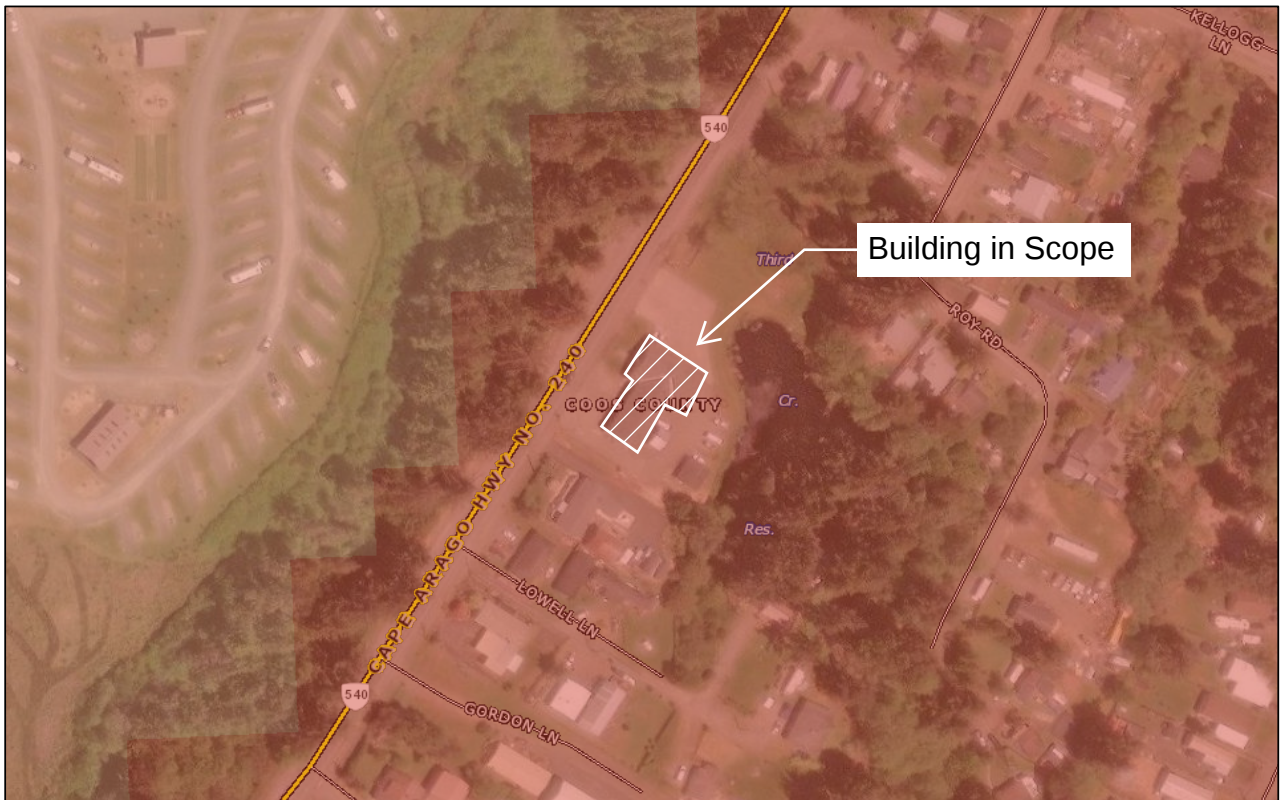
## Charleston Fire Station 1 - Liquefaction

The project is located within a liquefaction hazard area as identified by the DOGAMI Oregon HazVu. Due to the severity of the hazard and the recommendation of our geotechnical consultant (see **Appendix F**), we have included mitigation for this hazard within the scope of the retrofit.

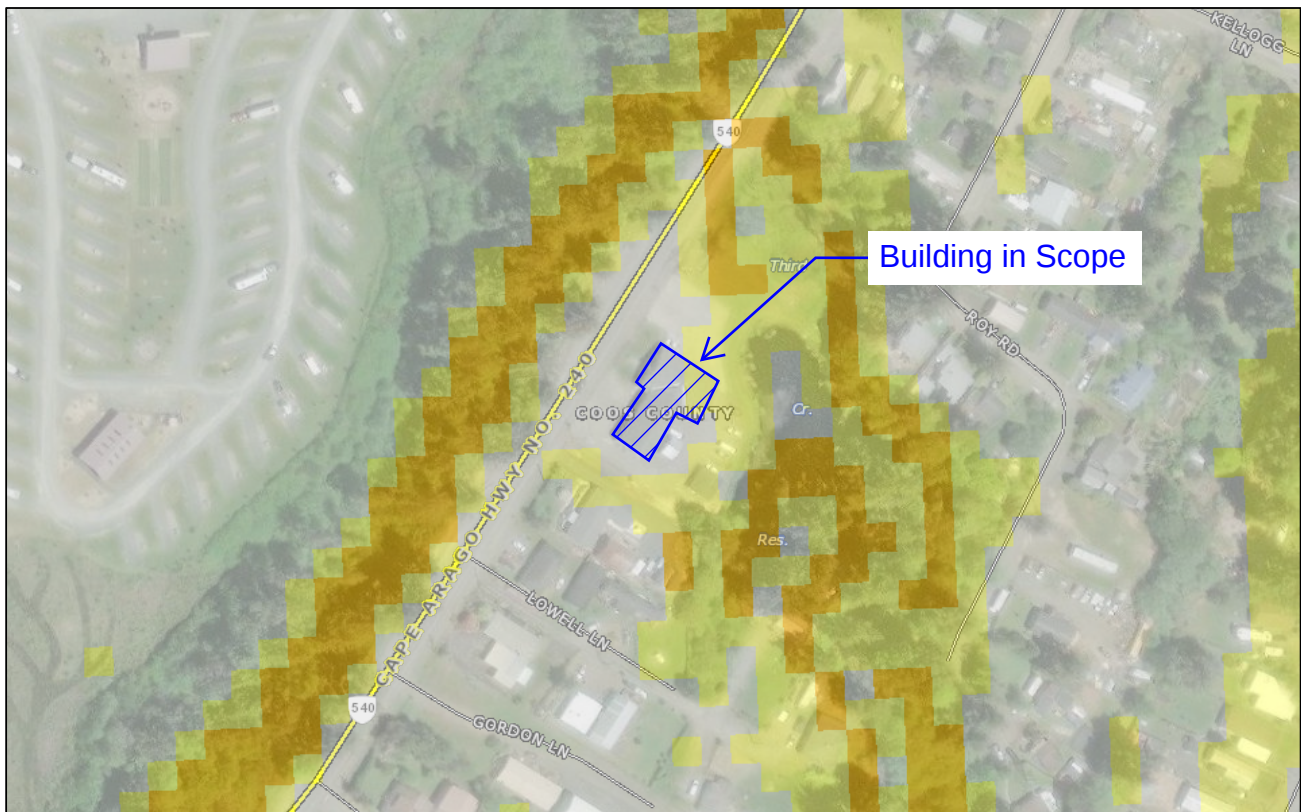
## Charleston Fire Station 1 - Landslide

The building is located within a landslide hazard area as identified by the DOGAMI Oregon HazVu. To ensure that an acceptable level of due diligence was performed during the application phase of the project, a geotechnical engineer was consulted and made recommendations based on available information with respect to severity. Per the geotechnical letter, attached in **Appendix F**, landsliding is not a design consideration and mitigation is not required.
