## SEISMIC EVALUATION REPORT

### Charleston Fire District

#### Seismic Assessment for Fire Station 1

January 23, 2026  
22045.00

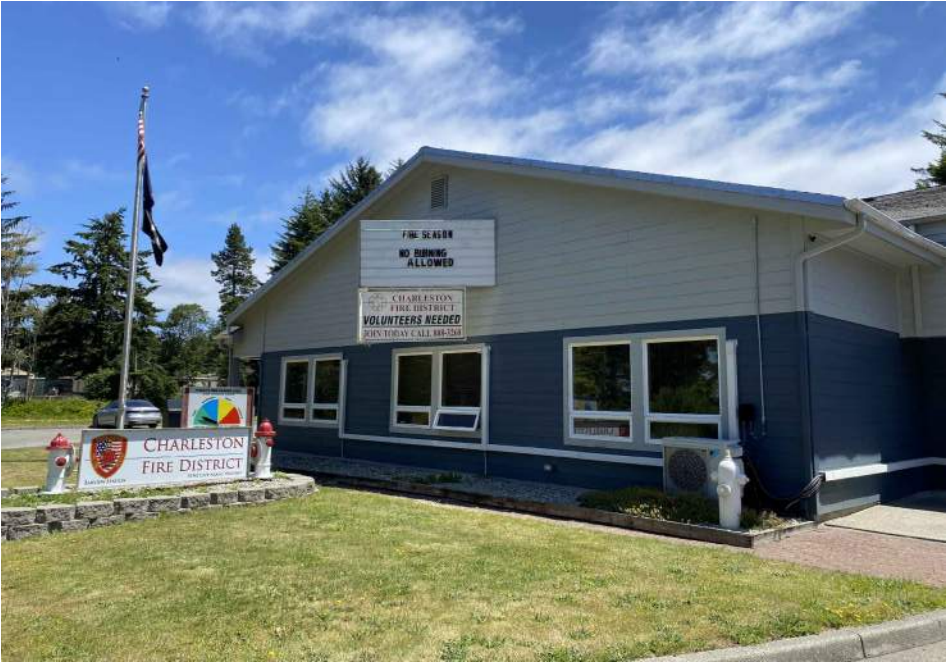
### STRUCTURAL DEFICIENCIES

- S15. THERE ARE NO CONTINUOUS CROSS TIES BETWEEN DIAPHRAGM CHORDS.
- S16. ANCHORS OF CONCRETE OR MASONRY WALLS TO WOOD STRUCTURAL ELEMENTS ARE NOT INSTALLED TAUT AND STIFF ENOUGH TO LIMIT THE RELATIVE MOVEMENT BETWEEN THE WALL AND THE DIAPHRAGM TO NO GREATER THAN 1/8 INCH BEFORE ENGAGEMENT OF THE ANCHORS
- S17. THE ESTIMATED DISTANCE BETWEEN THE STORY CENTER OF MASS AND THE STORY CENTER OF RIGIDITY IS GREATER THAN 20% OF THE BUILDING WIDTH IN EITHER PLAN DIMENSION.

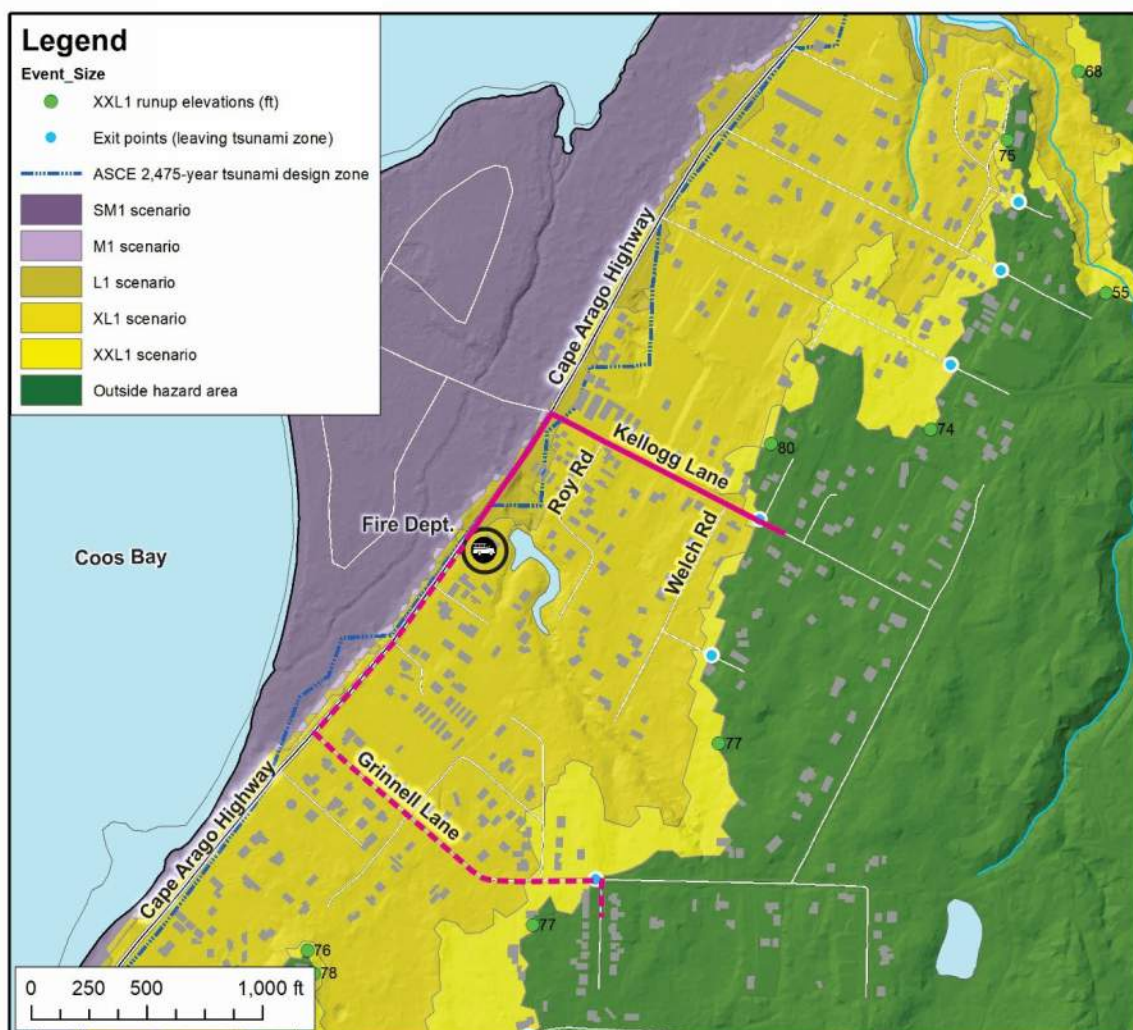
the SM1, M1 or L1 local CSZ scenarios but is inundated by events greater than and including the XL1 scenario. In addition, the fire station is outside of the 2,475-year tsunami design zone developed by the ASCE. As can be seen in **Figure 1** the fire station is relatively close to high ground, and evacuation out of the inundation zone may be accomplished along the following routes:

**Figure 1:** Map showing the five Cascadia tsunami inundation zones for the Charleston Fire Station 1 site, ASCE 2,475-year tsunami design zone, along with the existing planned evacuation route (solid magenta line) and optional secondary evacuation route (dash magenta line).

- an initial northward route along the Cape Arago Highway, before turning east on Kellogg Lane (total distance ~1,700 ft / 0.32 mi). This is the preferred evacuation route that is incorporated into the fire stations emergency plans for a Cascadia event.
- a second evacuation route could also be used. This additional route travels initially south along the Cape Arago Highway, before turning east on Grinnell Lane (total distance ~2,600 ft / 0.49 mi). This is a back-up route should evacuation along Kellogg Lane become compromised.
